CASE STUDY

Prevention of Limescale Deposits in Residential Water Heaters Using ScaleRX®

**METALLURGICAL TEST REPORT****Ref.** 332143 Rev. 1***Date:** June 23, 2020**Page** 1 **of** 5

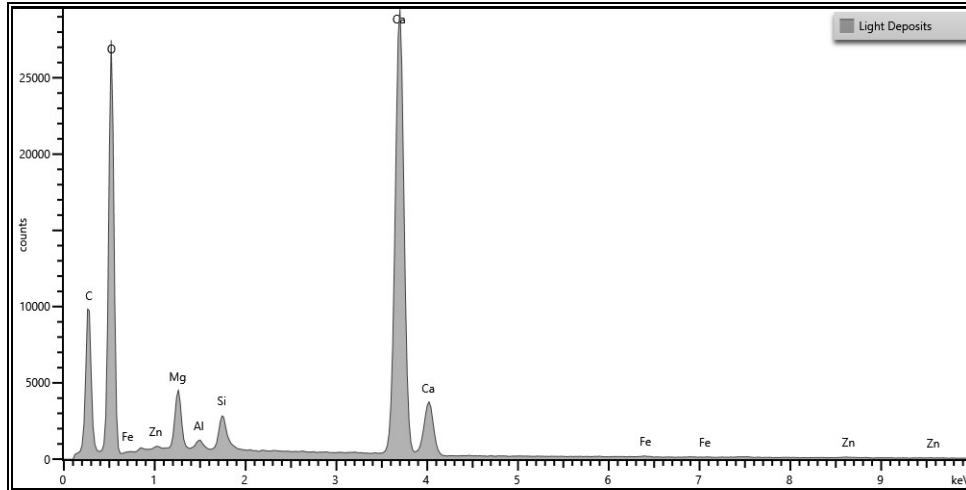
Figure 1: EDS spectrum of the lighter deposits exhibiting peaks at carbon (C), oxygen (O), iron (Fe), zinc (Zn), magnesium (Mg), aluminum (Al), silicon (Si), and calcium (Ca).

The spectra for both deposits exhibited peaks at carbon, oxygen, silicon, and calcium. The presence of iron, nickel, and aluminum is likely the result of shavings from the water heater tank. Spectra for both samples are shown in Figures 1 and 2.

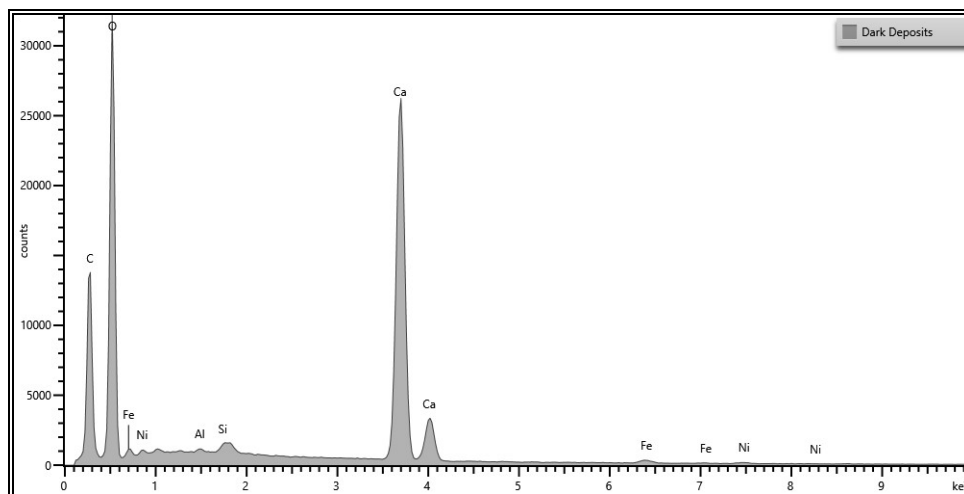
Figure 2: EDS spectrum of the darker deposits exhibiting peaks at carbon (C), oxygen (O), iron (Fe), nickel (Ni), aluminum (Al), silicon (Si), and calcium (Ca).

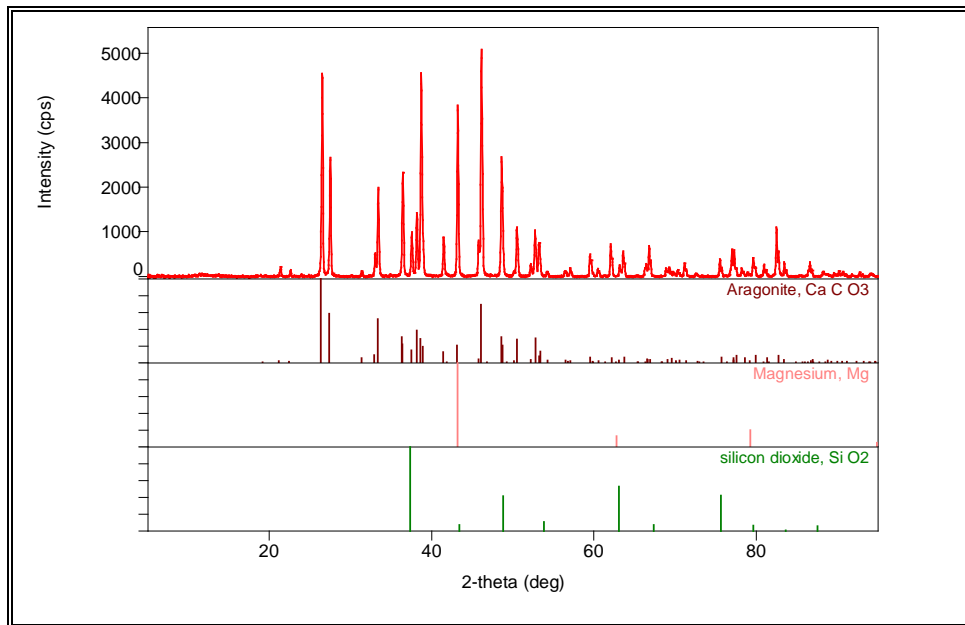
Figure 3: XRD pattern (top) and reference patterns (bottom) of the lighter deposits.

Aragonite (CaCO₃), magnesium, and silicon dioxide (SiO₂) were observed.

The samples were analyzed by x-ray diffraction (XRD) per ATS Procedure 962 Rev. 4, ASTM D 934-13 as a guide, and standard powder diffraction techniques using Cu K α radiation. The resulting x-ray patterns are shown in Figures 3 and 4. Aragonite (CaCO₃) was observed in both samples. Magnesium and silicon dioxide was observed in the lighter deposits, while aluminum oxide and silicon carbide were observed in the darker deposits.

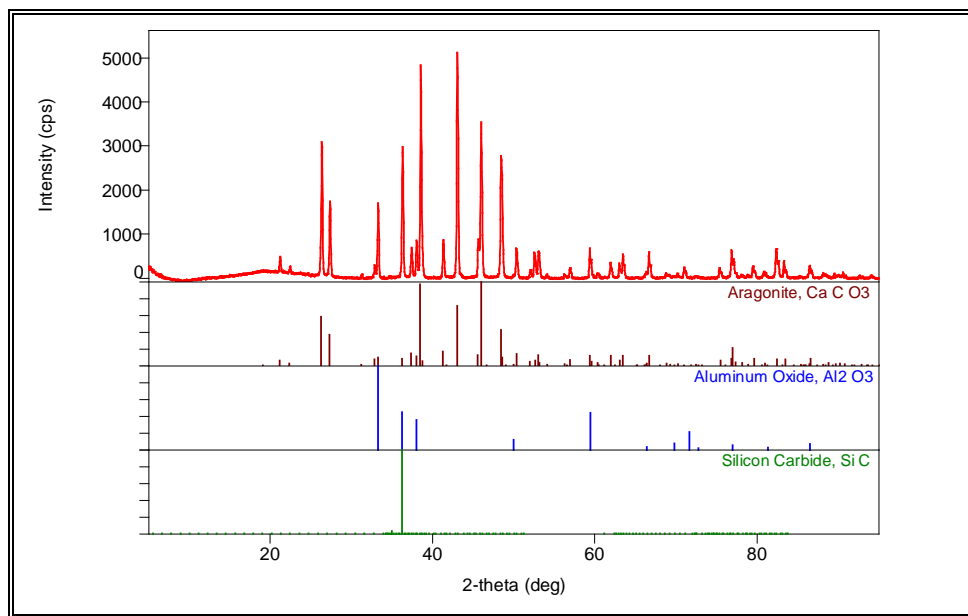
Figure 4: XRD pattern (top) and reference patterns (bottom) of the darker deposits.

Aragonite (CaCO₃), aluminum oxide (Al₂O₃), and silicon carbide (SiC) were observed.

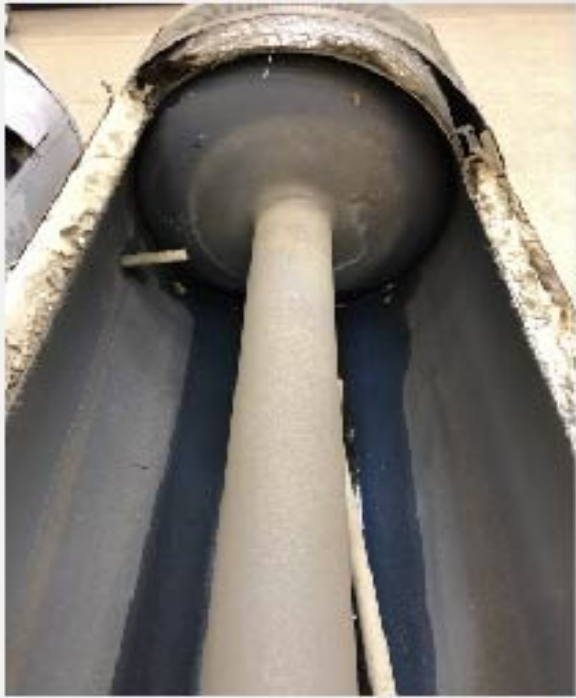
Figure 1: Test Unit A with ScaleRX® installed

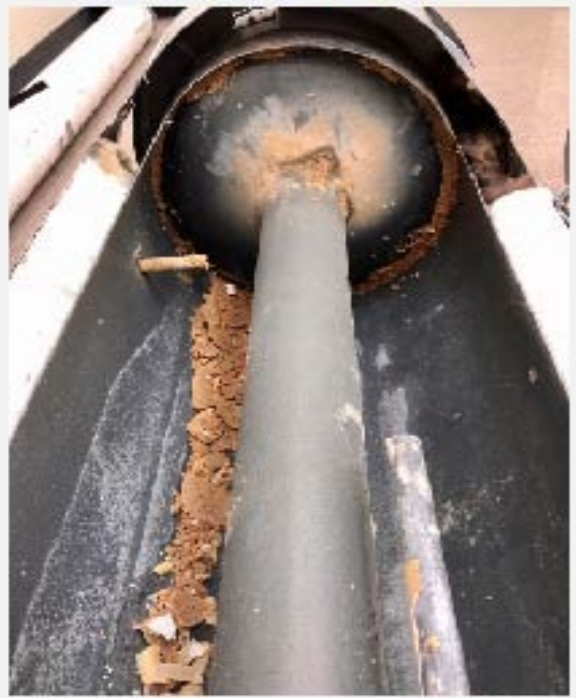
Figure 2: Test Unit B without ScaleRX® installed

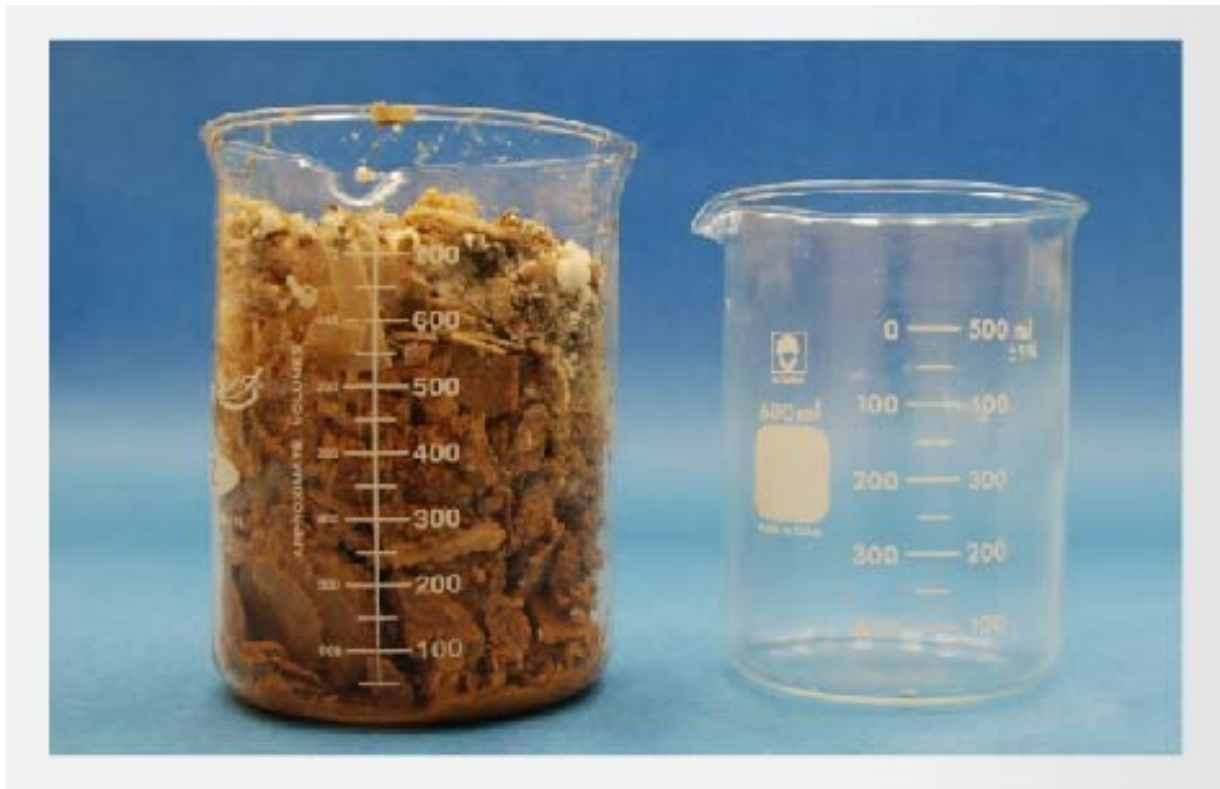
Figure 3: 1 liter or 320 g of scale deposit removed from Test Unit B (without ScaleRX®)

After one year, the unit installed without ScaleRX® produced 500 ml (320 g) of scale deposits. Whereas the unit installed with ScaleRX® produced zero scale deposits.

Two colorations of deposits were observed inside water heater Unit B. Both samples were analyzed using energy-dispersive spectroscopy (EDS) and x-ray diffraction (XRD). There were no observable deposits in Unit A. The deposits collected from Unit B had a volume of approximately 500 mL and an approximate mass of 320 g.

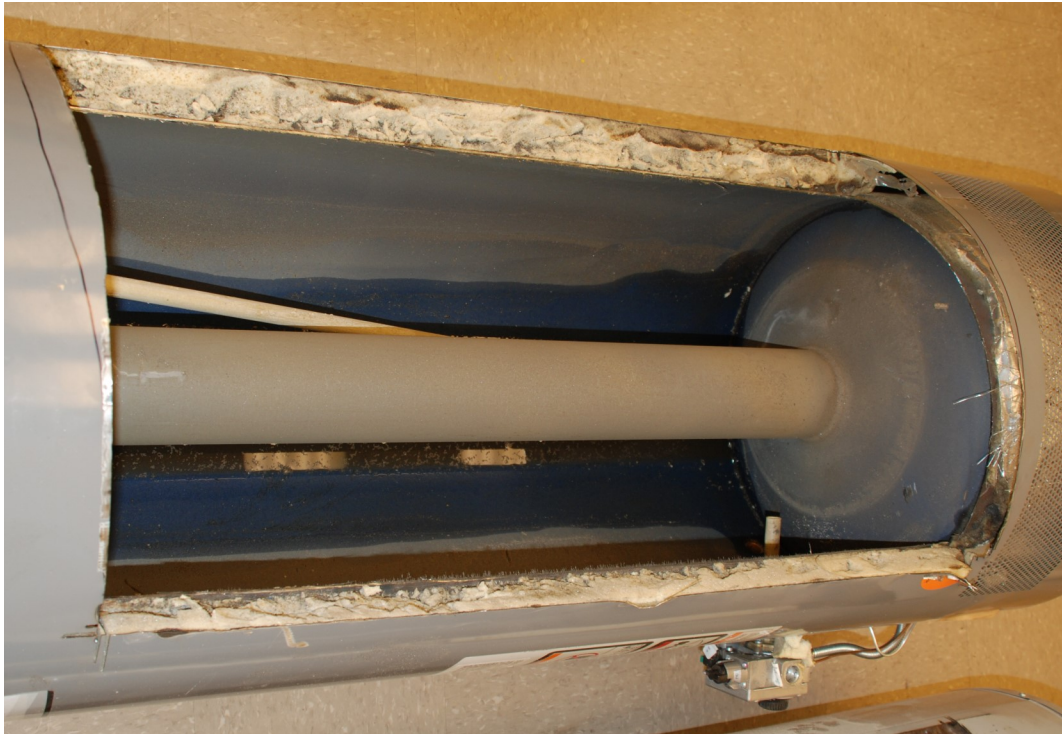
Figure 4: Test Unit A with ScaleRX® installed

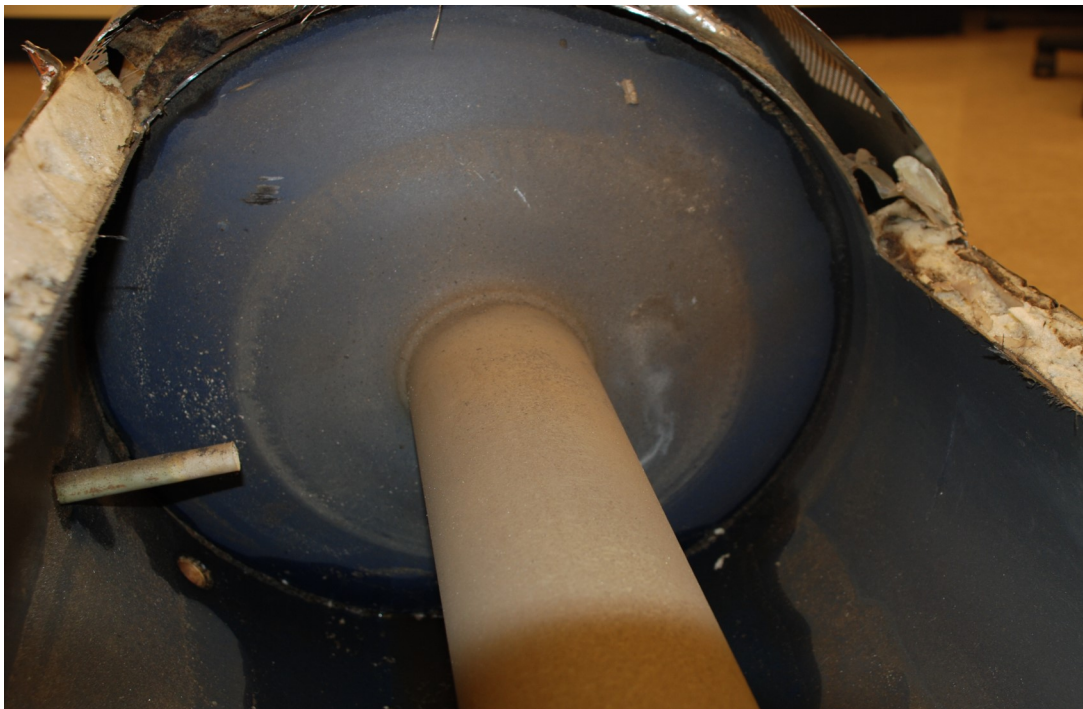
Figure 5: Test Unit A with ScaleRX® installed

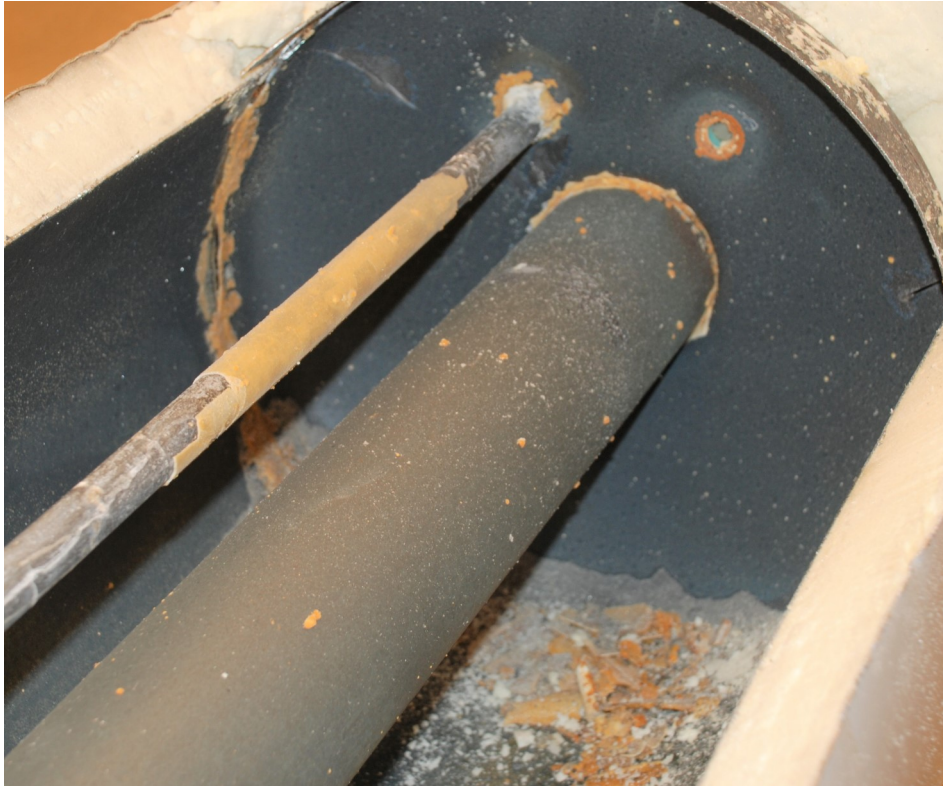
Figure 6: Test Unit B without ScaleRX® installed

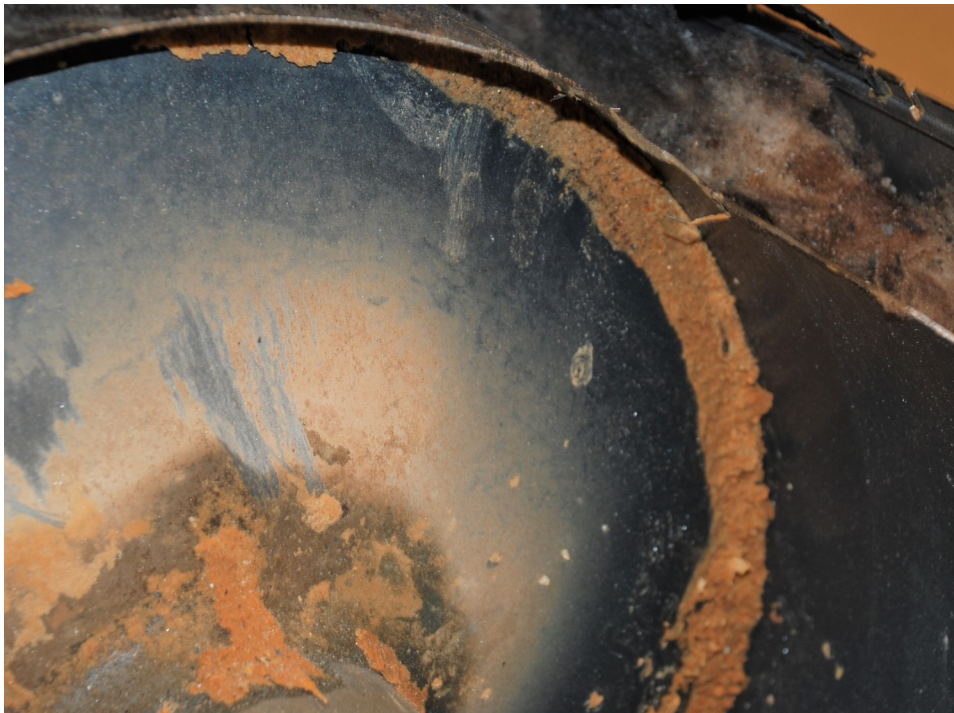
Figure 7: Test Unit B without ScaleRX® installed
